# CITY OF PIEDMONT

## Park Commission Agenda Wednesday, May 1, 2019 5:30 p.m.

**Tree Assessment**  
Magnolia Avenue  
Department of Public Works  
Piedmont CA

# Tree Assessment

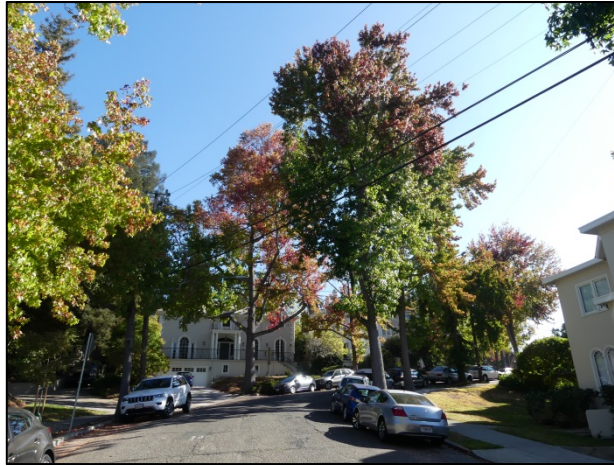
**Photo 1.** Looking east along section of Magnolia Ave.

Seventy (70) sweetgum (*Liquidambar styraciflua*) trees were evaluated along Magnolia Avenue. All trees were located in the planting strip between curb and sidewalk (Photo 1). The planting strip was generally 24-inches wide. Groundcover in the planting strip varied from bare ground to turf to low shrubs. Overhead electrical lines were present and varied from either the north or south side of the street.

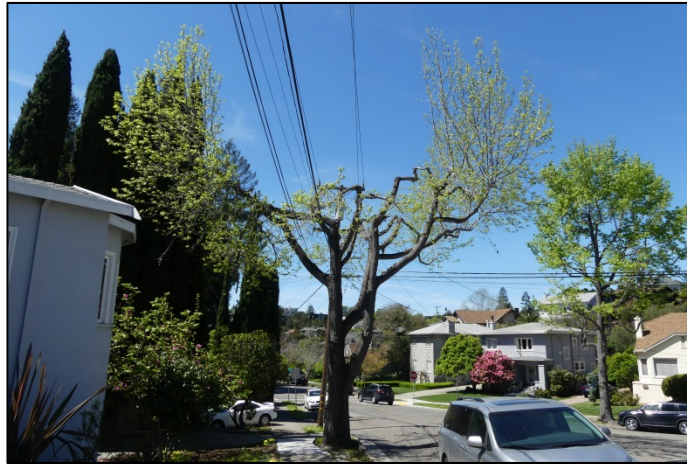
**Photo 2.** Tree #36 was located below overhead electrical lines and had been topped numerous times.

Tree condition was variable. Eleven trees were in very poor condition and 40 were in poor condition. Seventeen trees were in fair condition while #68 and 82 were good. The primary factors influencing tree condition were overall form and structure and general vigor. Trees located below or adjacent to electrical lines had been topped (Photo 2). Other trees had been topped, in some cases more than once.

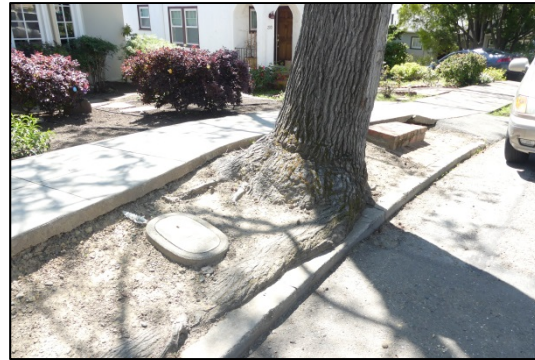
Large roots and tree bases were often present within the planting strip, often filling the space between sidewalk and curb. In some cases, root extended into adjacent lawns (Photo 3). Tree roots had lifted and displaced the adjacent sidewalk near 60 of the 70 trees. Displacement was severe in 37 trees. Sidewalk adjacent to six trees was new. The adjacent curb was displaced in 45 of the 70 trees. I observed several instances where buttress roots had been pruned.

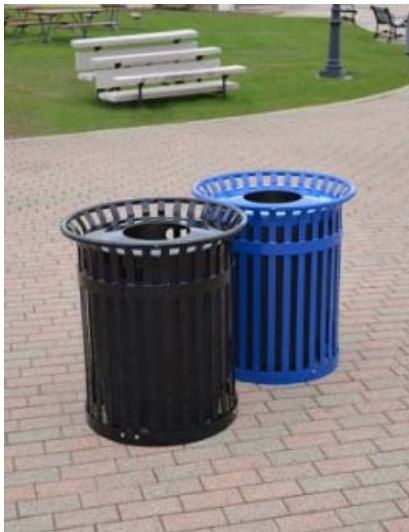
Three different color containers, black for garbage, green for compostable and blue for recycling, metal design, serviced from the top. Units could be placed in clusters or in pairs.
